3.1 Climate Change

3.2 Coastal processes

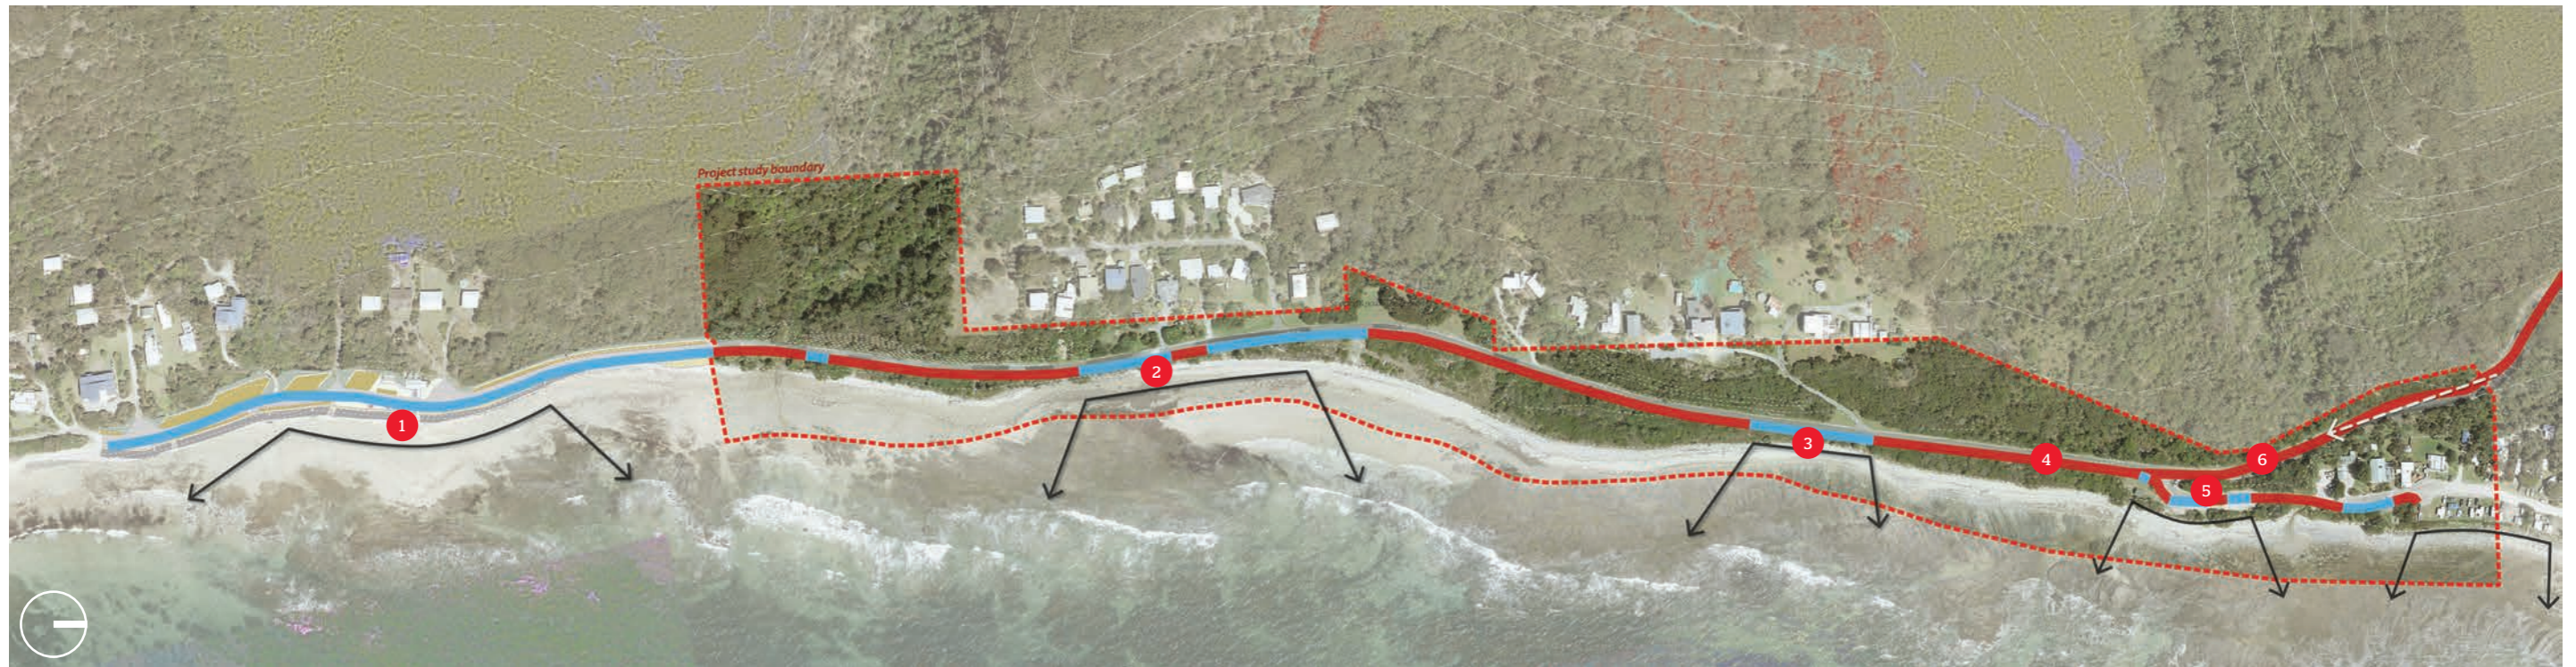
Figure 12 Pattern of viewing

- Car based viewing patterns are typically based around an elevated arrival point and expansive views in both north and south Walkerville, and then framed 'glimpse views' of the water and relatively short road based views in Bayside Drive caused by the meandering road alignment and enclosing vegetation in most of the study area. More expansive views are available in the south (Hall location) and the north (camping ground).

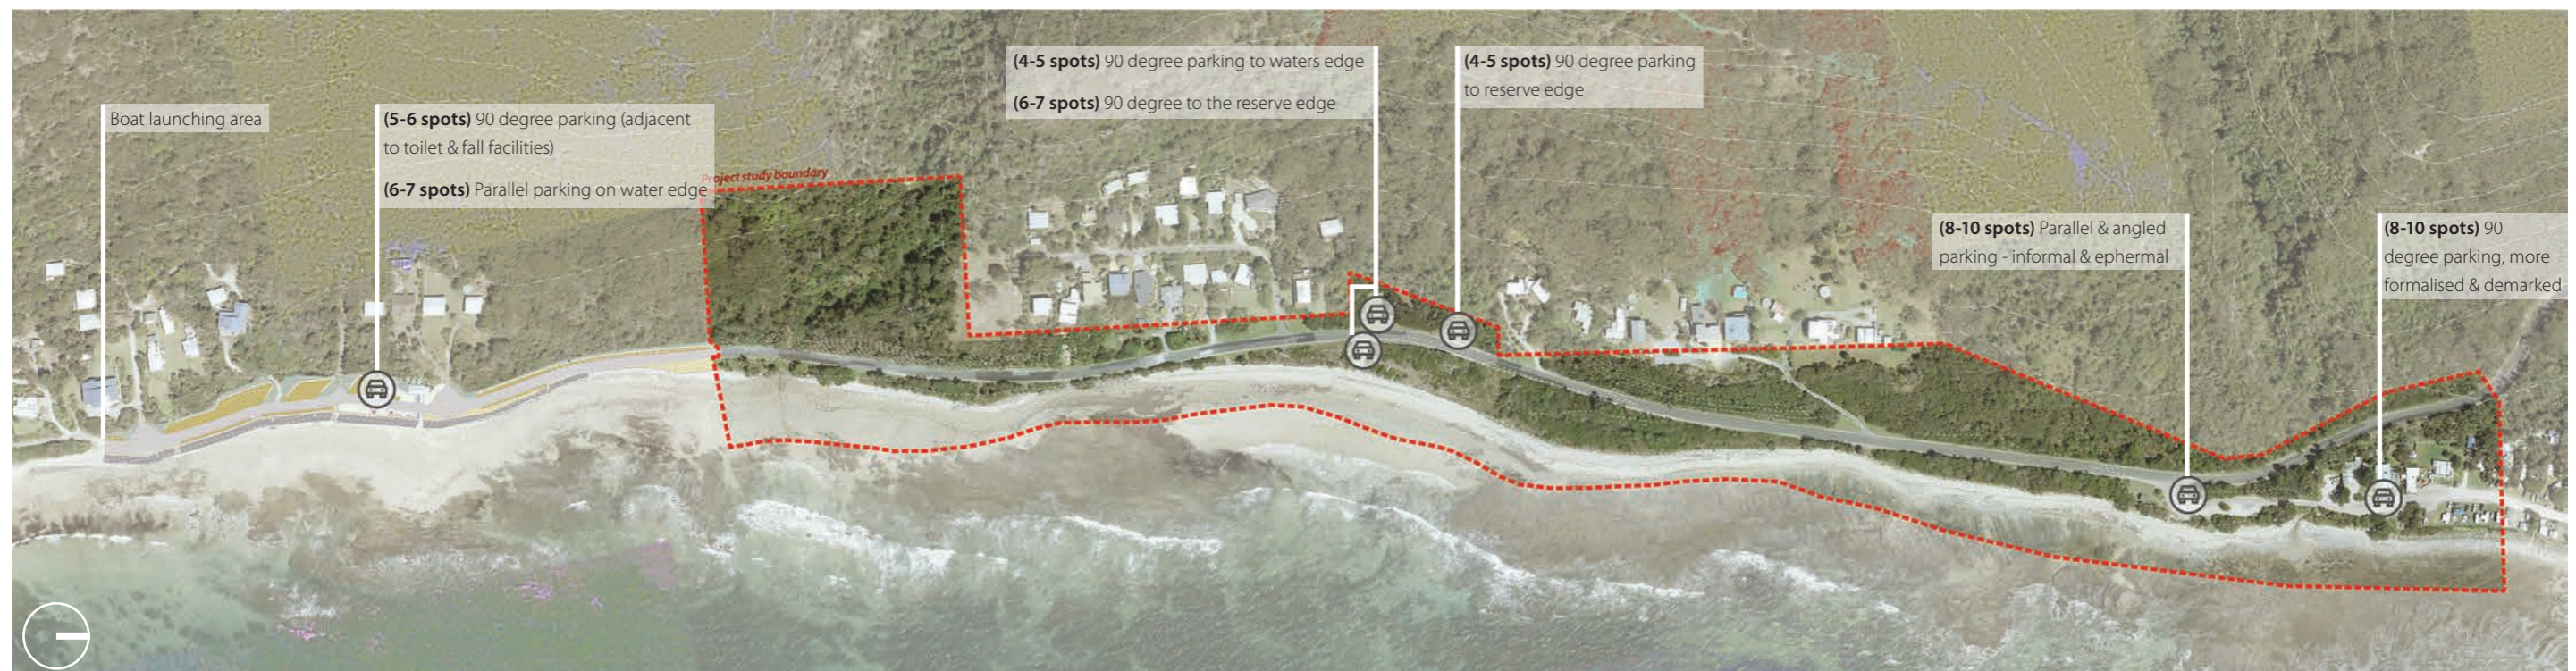
Figure 15 Parking locations plan

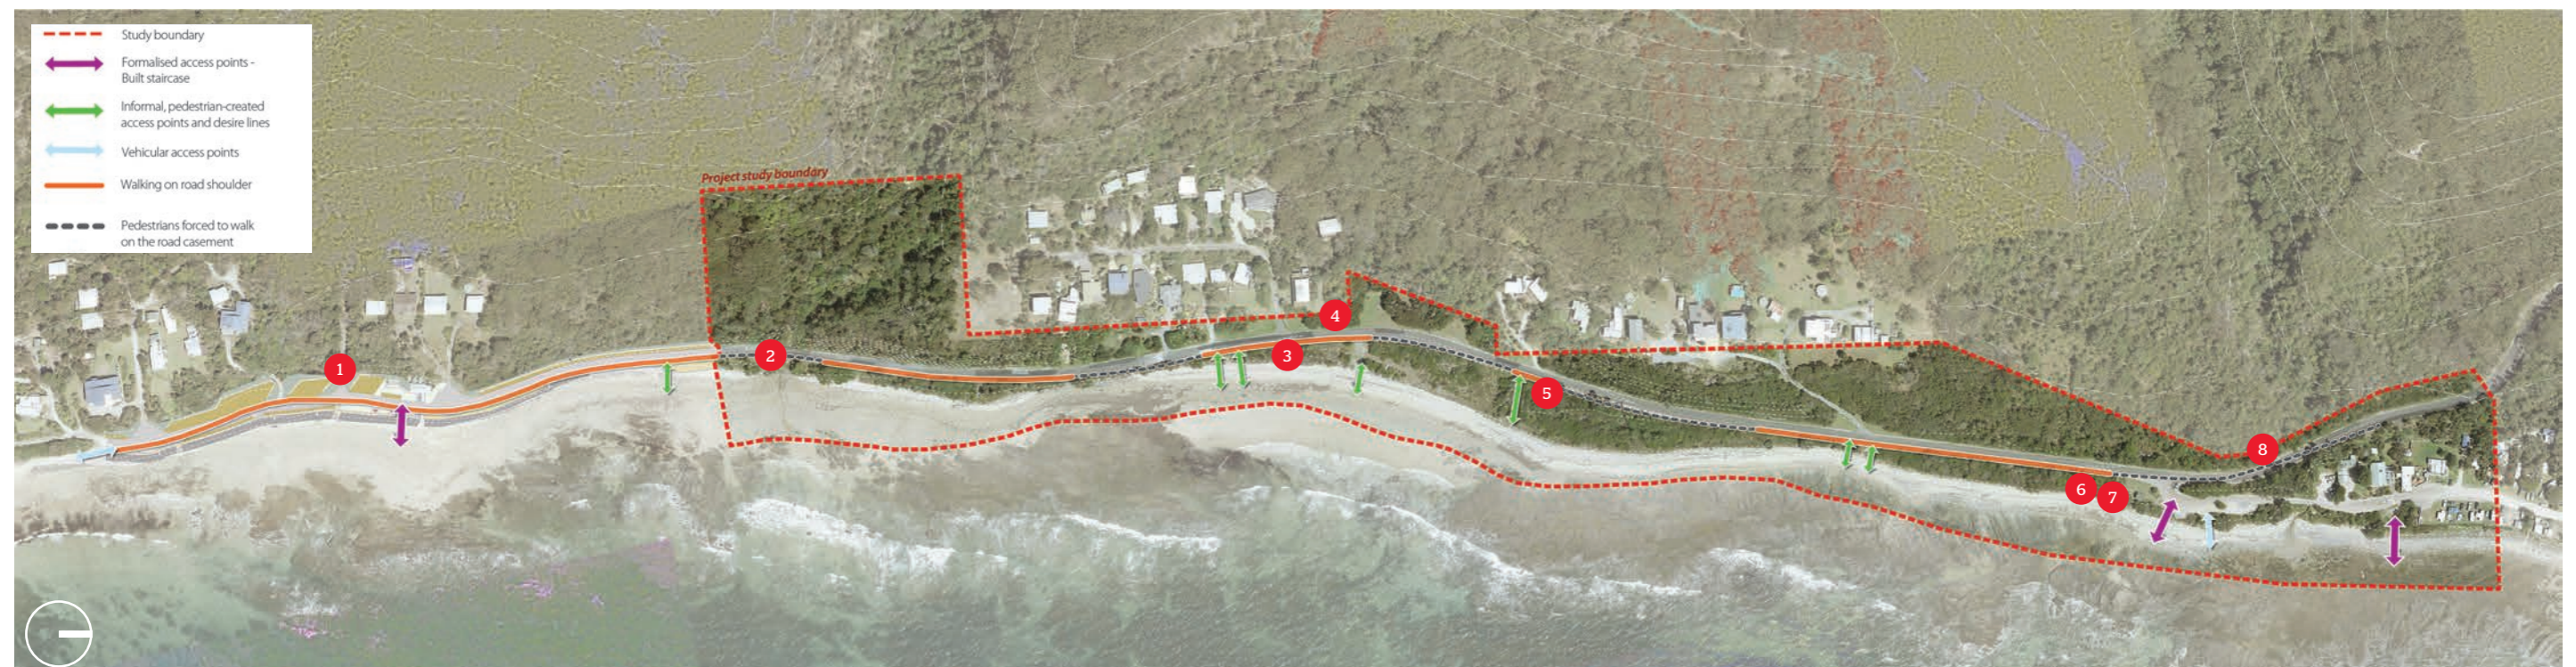
Figure 16 Access and movement analysis

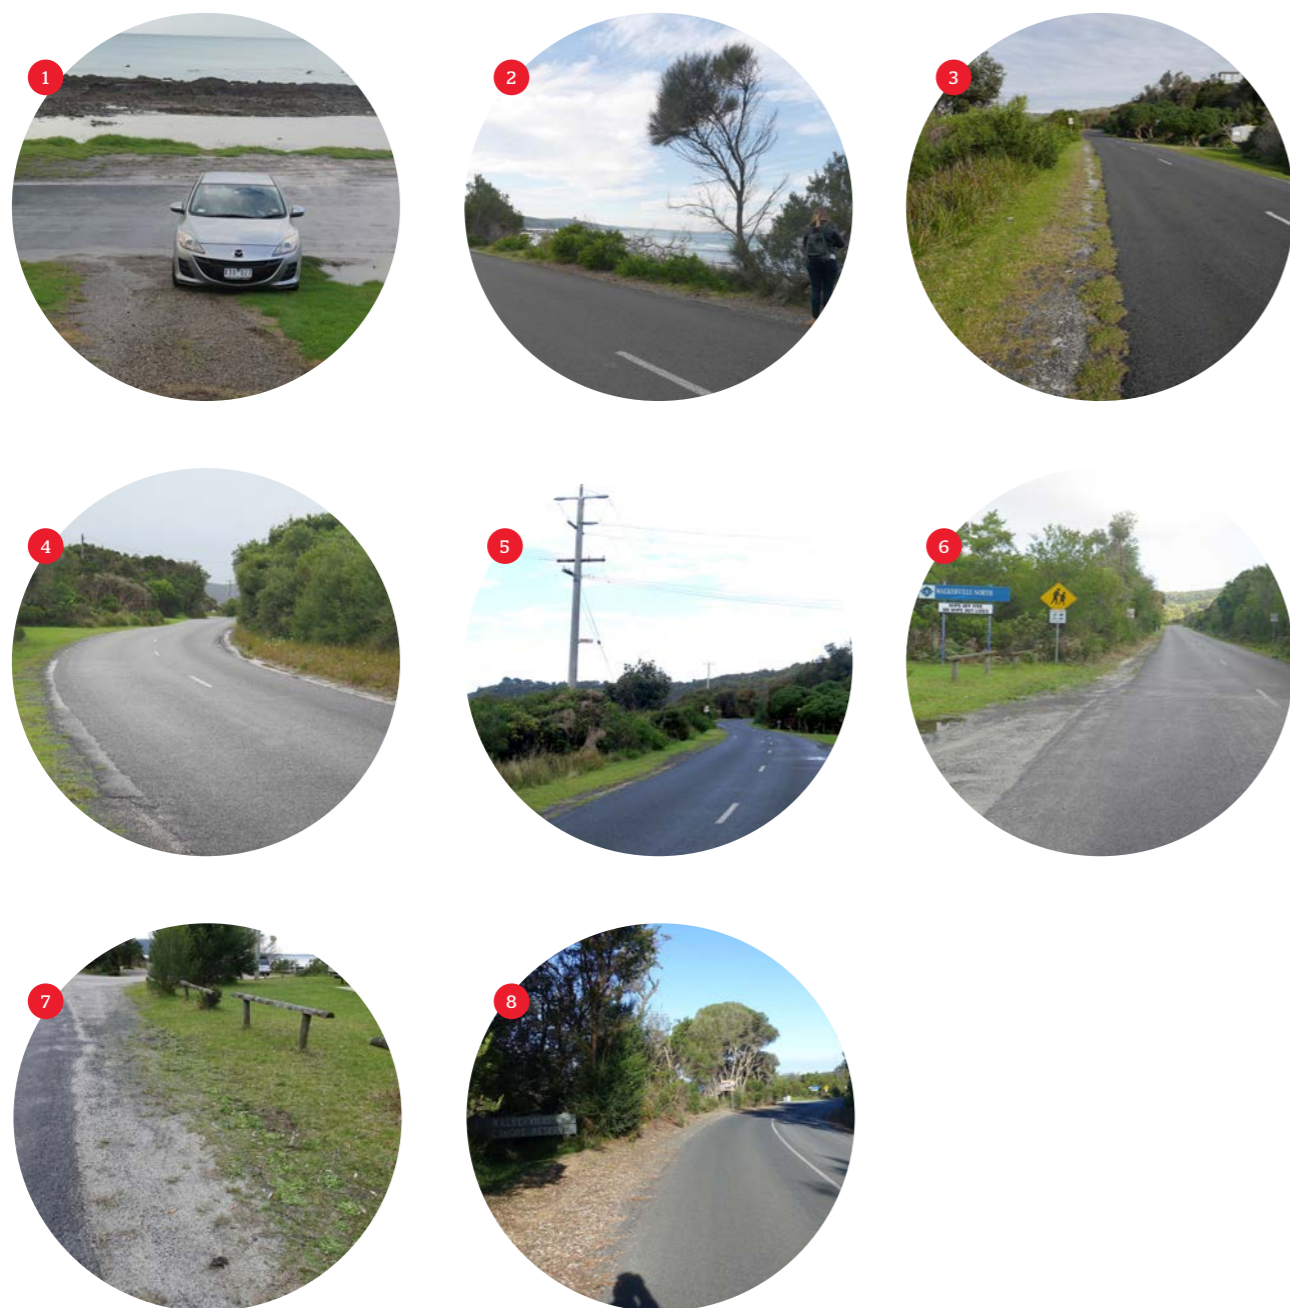
Figure 17 Existing trails network - wider context plan

- Walkerville is surrounded by a number of walking tracks through State Park – none directly connect to the project area. The tracks are generally limited by the steep topography of the landscape and waterways, as seen in Figures 16 & 17. The most utilised walking tracks are those to South Walkerville and Promontory Views Estate.

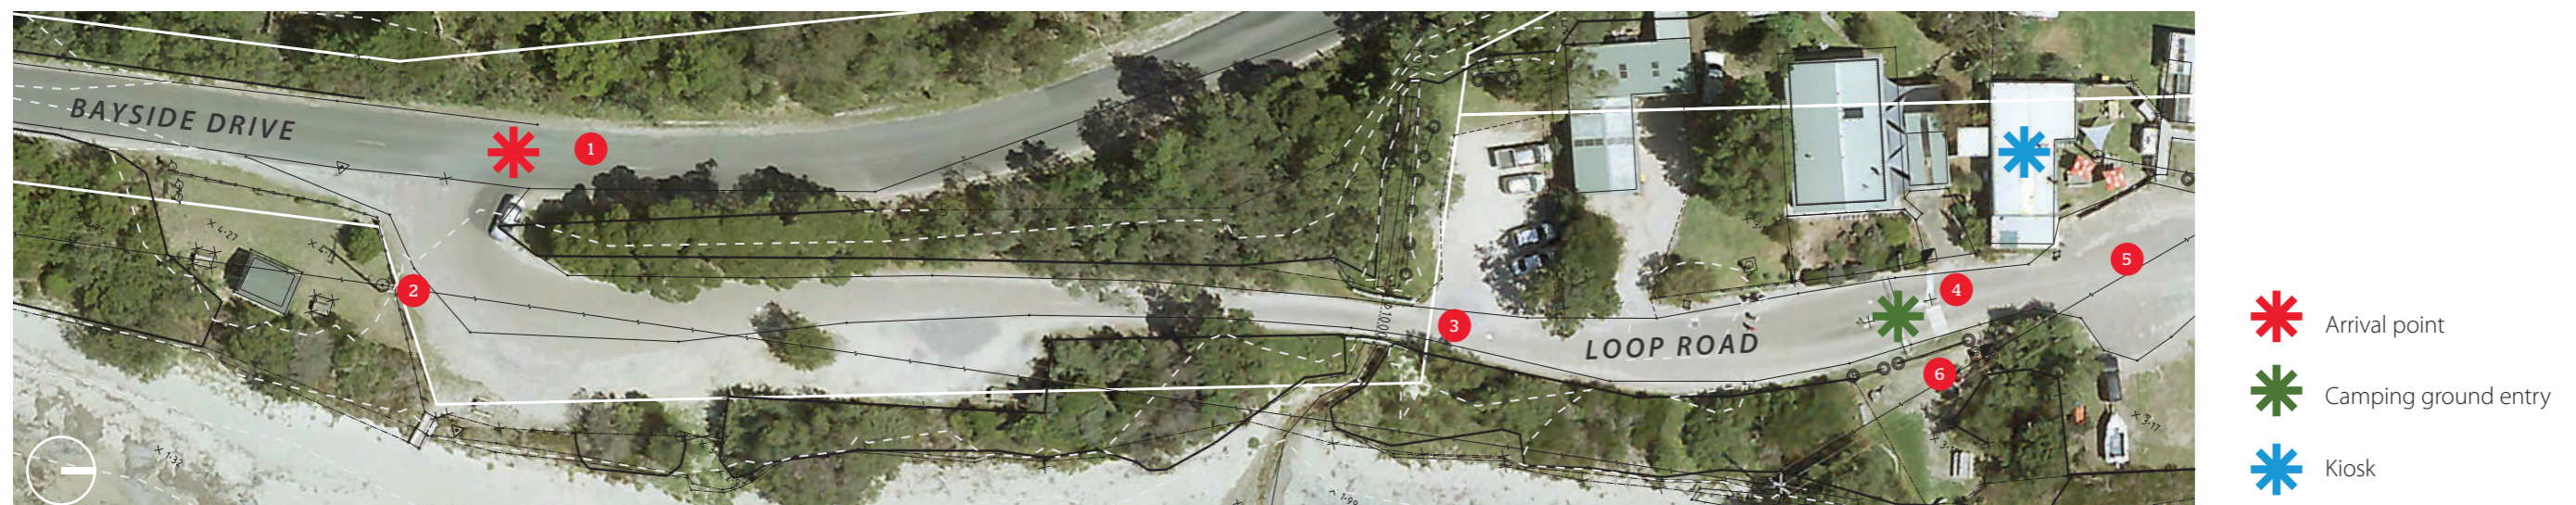
Figure 18 Walkerville arrival point, camping ground entry and Kiosk

- The location of the control gate requires kiosk delivery trucks to enter through the control gate, to load from the roadway and do a three point turn within the site in order to leave. This creates congestion at the entry point and is unsafe for pedestrians, including children who are drawn to the kiosk location.

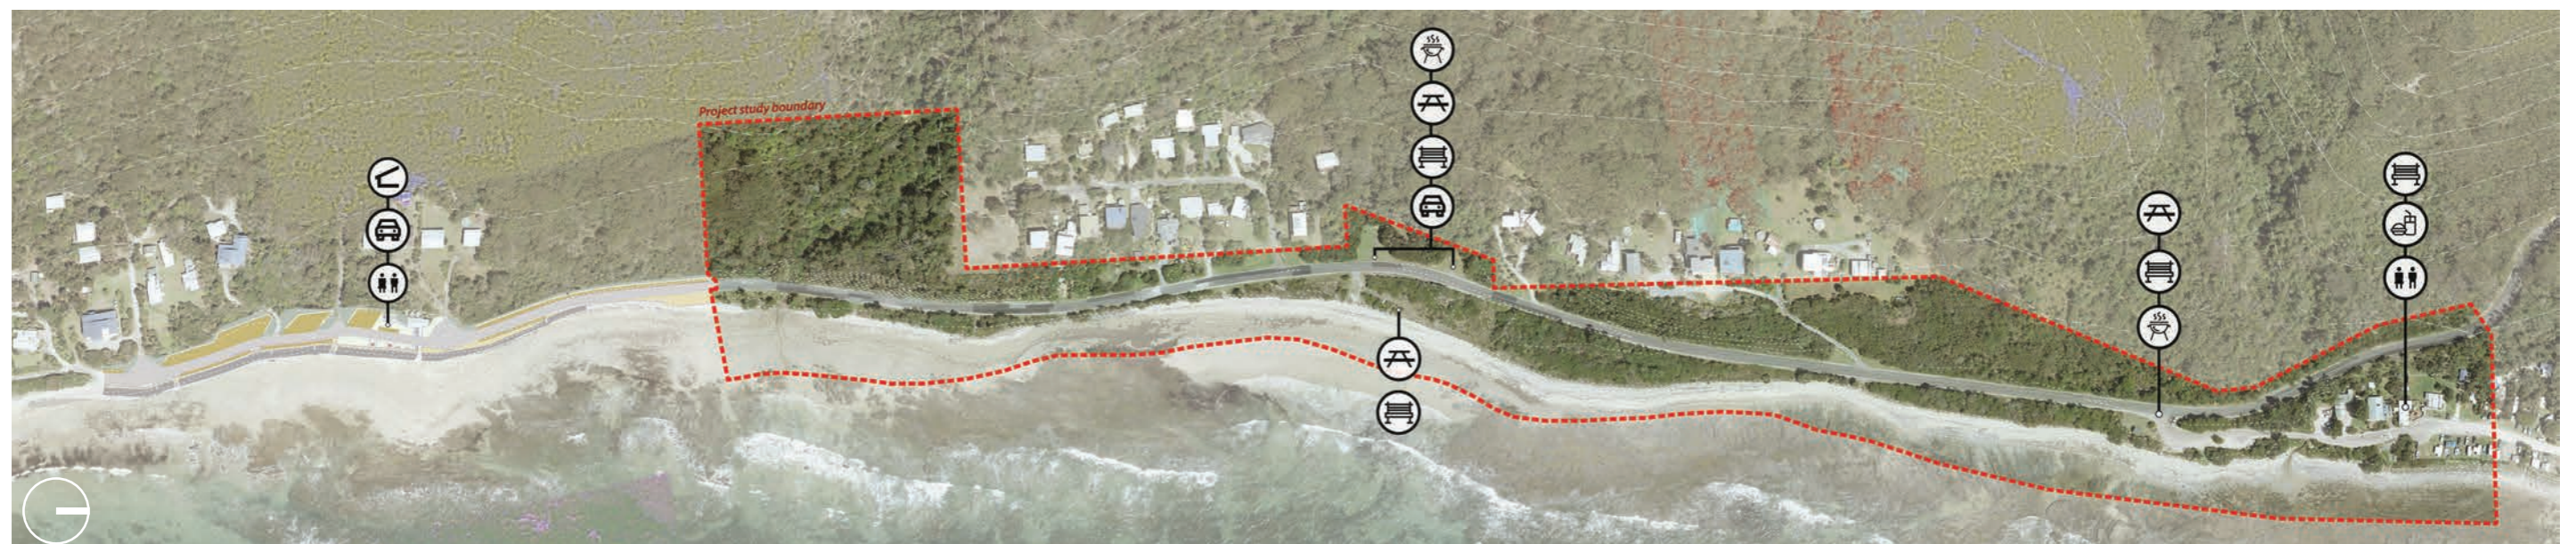
Figure 19 Experience analysis

The foreshore has a no bins policy, which is reported to be generally successful. Consultation comments suggest a wish for bins within the reserve at key locations. Rubbish deposits (bagged visitor rubbish) within the existing toilet facility suggest that there is a need for at least one rubbish collection point within Walkerville (outside the camping ground).

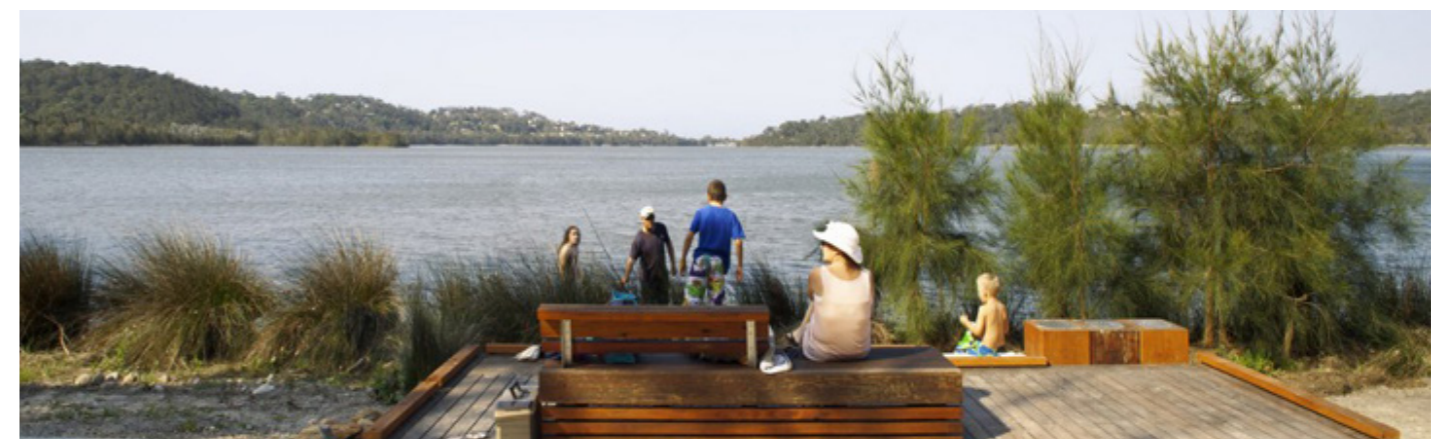
Narrabeen Lagoon Multi-Use Trail, NSW (2011)
by Aspect Studios

The 2.5km multi-use trail facilitates access and the use of Narrabeen Lagoon's natural resources. The timber and fibreglass lookouts and trails sit respectfully within the landscape, complementing the setting with minimal impact to the landscape and key views.
